Case 253 : Narrative

Case Vehicle (A): 1999 Chevrolet
Type: Silverado 1500, 4x4, 4-door pickup
Driver: 40-year-old male
CDC: 12-FCEN-2

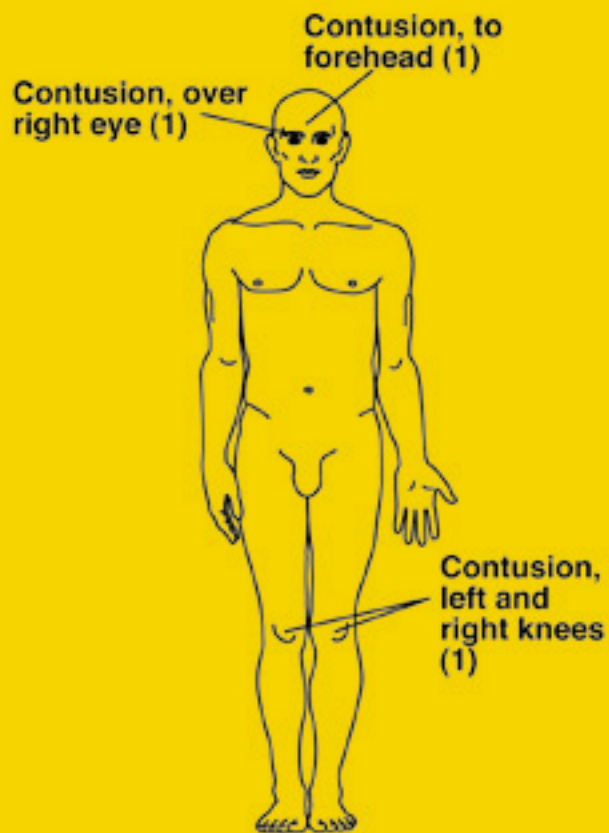
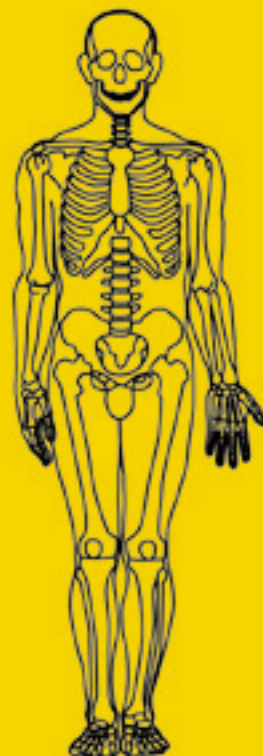
Occupant: Driver	Age: 40 years	Gender: Male		
Restraints: 3-point belt <i>not</i> worn; airbag deployed	Stature: 175 cm (5 ft, 9 in)	Mass: 79 kg (175 lb)		
Injury Description	A.I.S.	Injury Source		
—	—	Definite	Probable	Possible
Contusion, forehead	1	—	Airbag	—
Contusion, over right eye	1	—	Airbag	—
Contusion, left knee	1	Knee bolster	—	—
Contusion, right knee	1	Knee bolster	—	—
Maximum A.I.S. Level	1	—	—	—
Injury Severity Score	1	—	—	—

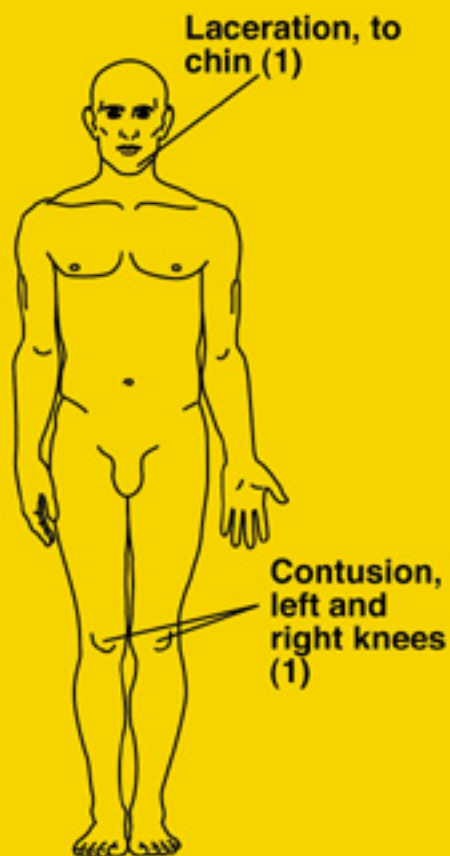
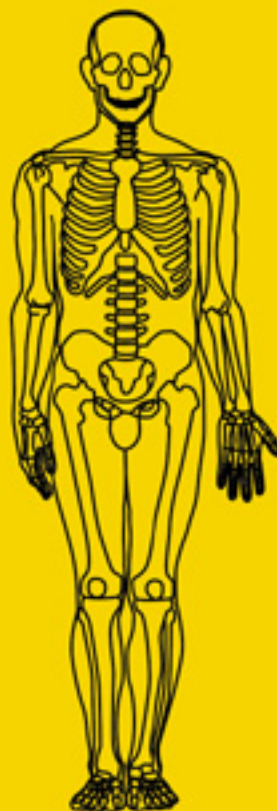
Occupant: Right front	Age: 34 years	Gender: Male		
Restraints: 3-point belt <i>not</i> worn; airbag deployed	Stature: 175 cm (5 ft, 9 in)	Mass: 79 kg (175 lb)		
Injury Description	A.I.S.	Injury Source		
—	—	Definite	Probable	Possible
Laceration, chin	1	—	Windshield	—
Contusion, left knee	1	Glove box	—	—
Contusion, right knee	1	Glove box	—	—
Maximum A.I.S. Level	1	—	—	—
Injury Severity Score	1	—	—	—
